SES System Efficiency Service identifies pressure surges as cause of damage

Chemical park

Pump measurement with high sample rates sheds light on the cause.

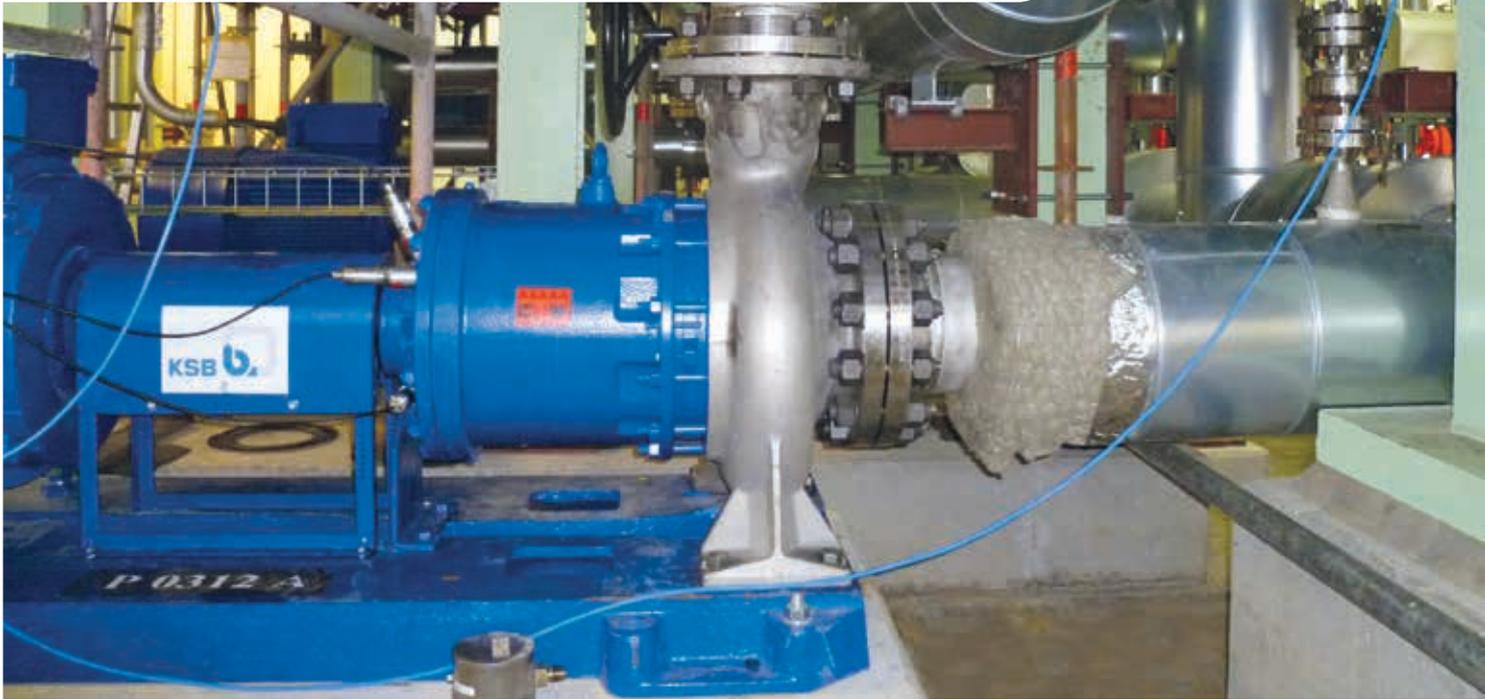
During plant operation, the mag-drive pumps failed repeatedly within a very short time. Both pumps showed signs of rubbing contact in the pump casing and destroyed plain bearings.

These two damage symptoms indicate large forces acting on the pump rotor; such forces cannot result from normal pump operation after such a short operating time. The operator's process data displays no signs of irregularities in plant operation.

Broken bearing bush of process pump

KSB's measurement revealed that pressure surges only occur at specific times when steam is fed in to increase the fluid temperature. Based on this piece of information, measures were defined together with the plant operator to prevent pressure surges.
